DUNMORE NO. 3 DAM

NDI ID NO. PA-00376

PENNSYLVANIA GAS AND WATER COMPANY

PHASE I INSPECTION REPORT
NATIONAL DAM INSPECTION PROGRAM

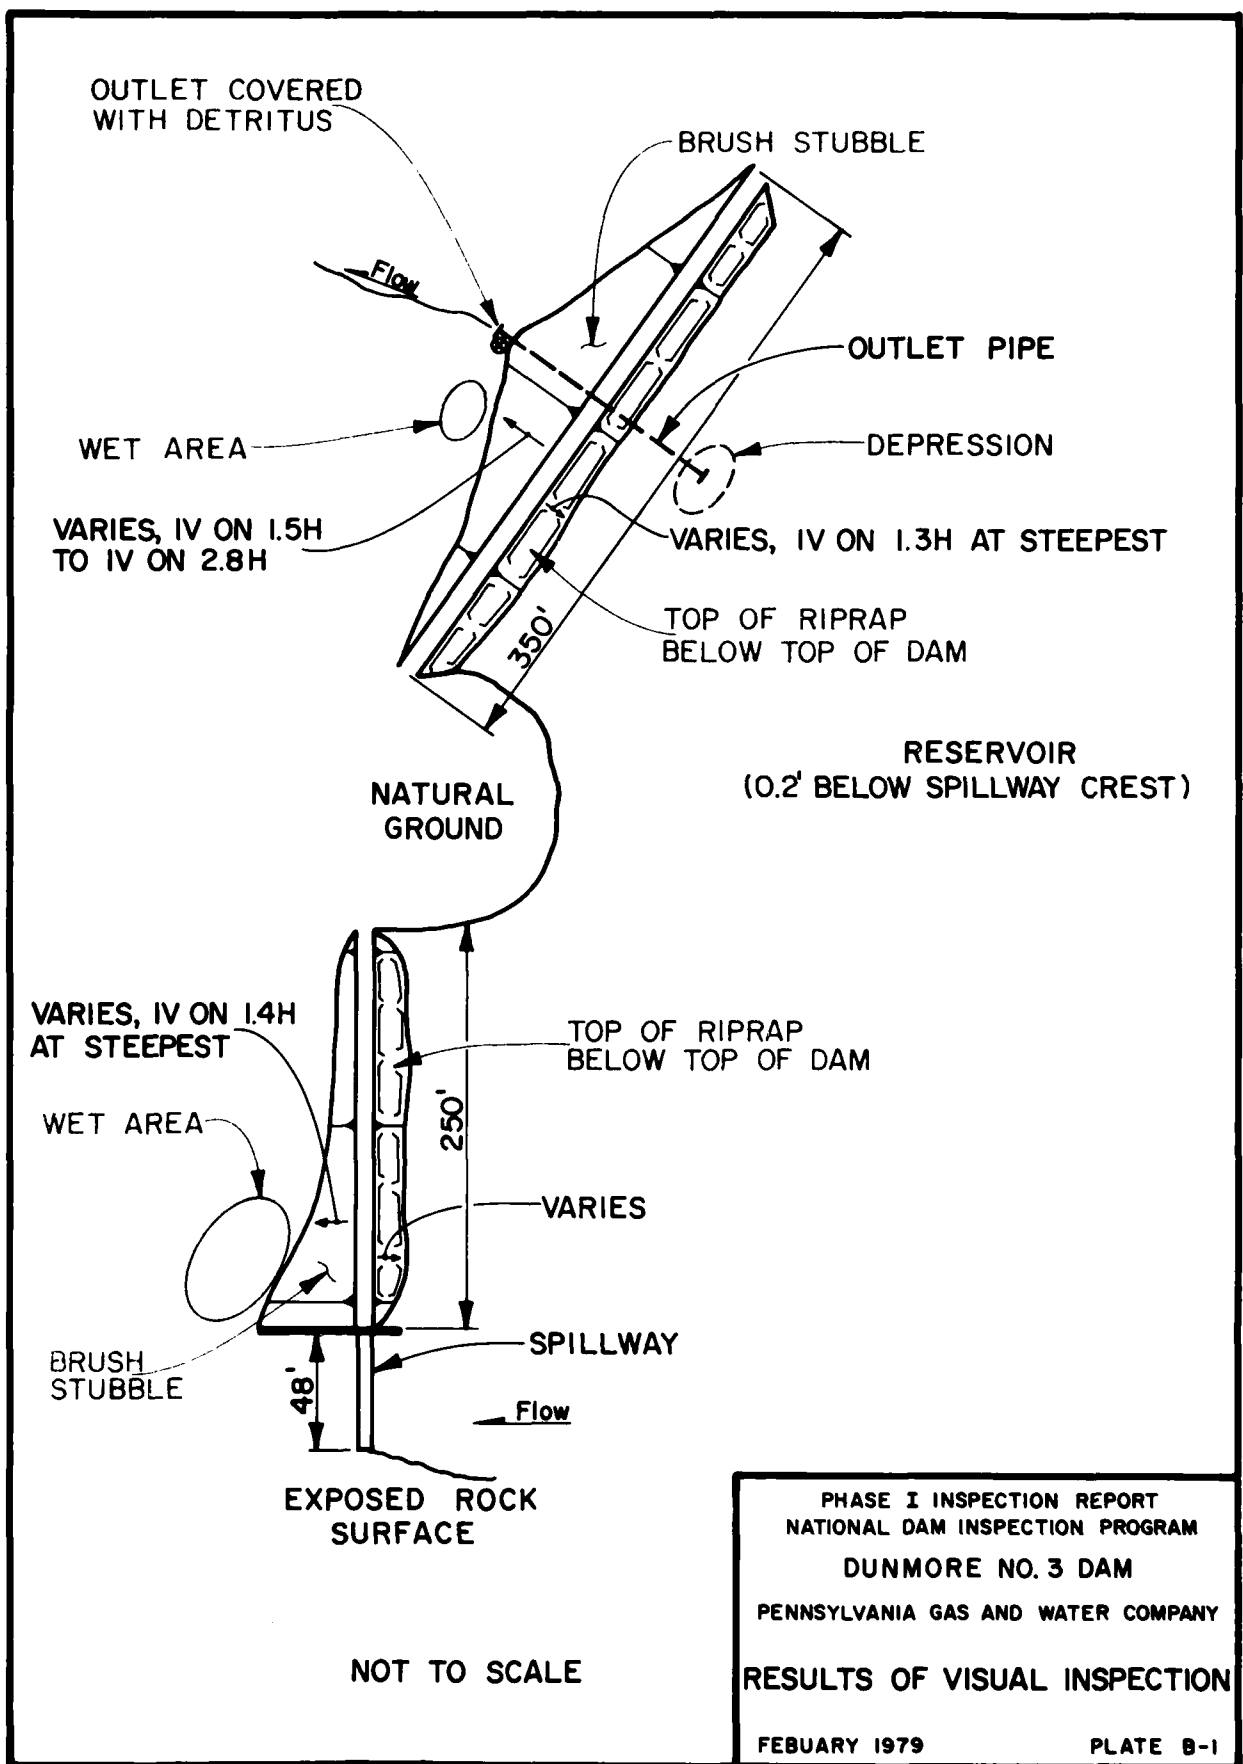
PHASE I INSPECTION REPORT
NATIONAL DAM INSPECTION PROGRAM
DUNMORE NO. 3 DAM
PENNSYLVANIA GAS AND WATER COMPANY
RESULTS OF VISUAL INSPECTION
FEBRUARY 1979
PLATE B-1

a. General. The overall appearance of the dam was fair, with some deficiencies as noted herein. The locations of some of these deficiencies are shown in Appendix B on Plate B-1. Survey data acquired during this inspection is presented in Appendix B. On the day of the inspection, the pool was 0.2 foot below spillway crest elevation.

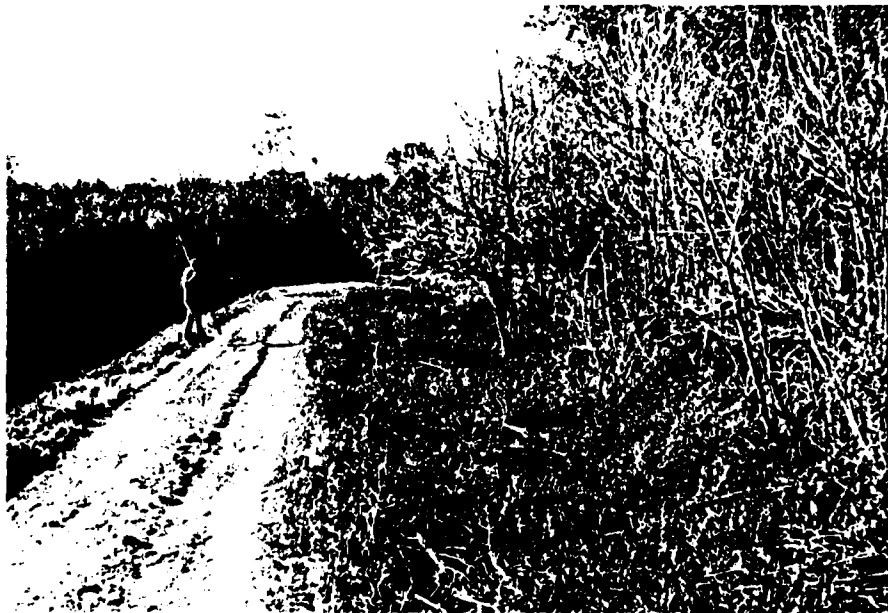
D. Left Embankment
View from Right Abutment
